Preliminary Field Investigation of Damage Caused by Hurricane Matthew

David O. Prevatt, Ph.D.
University of Florida

Hurricane Matthew

September 28-October 9, 2016

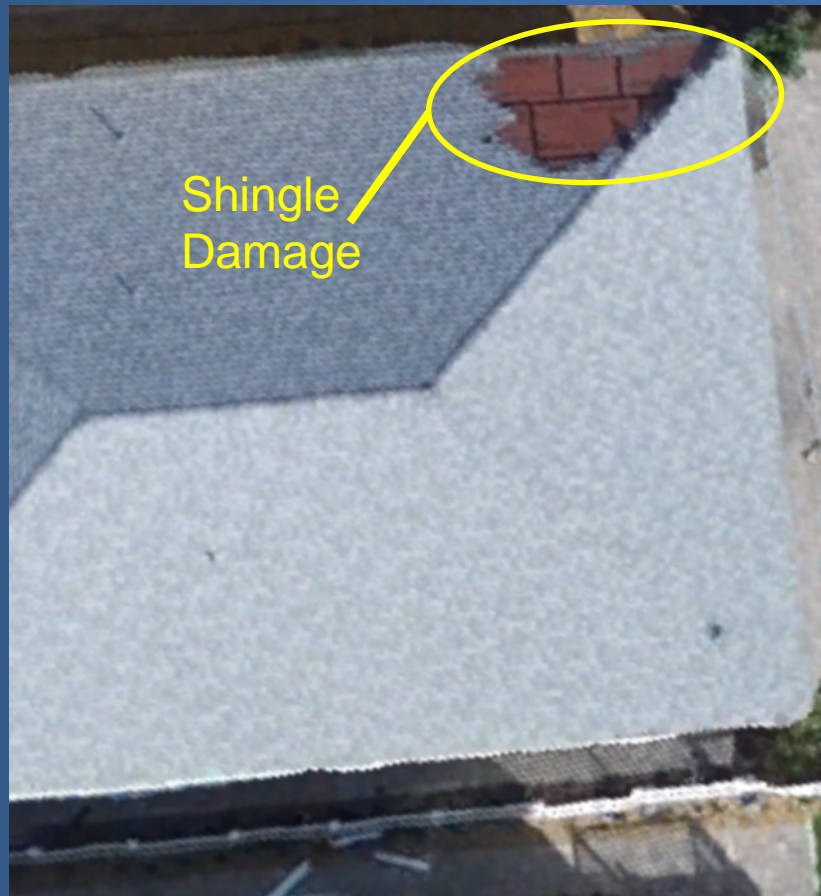
1424 S Oceanshore Blvd, Flagler Beach, FL

Year Built: 2015

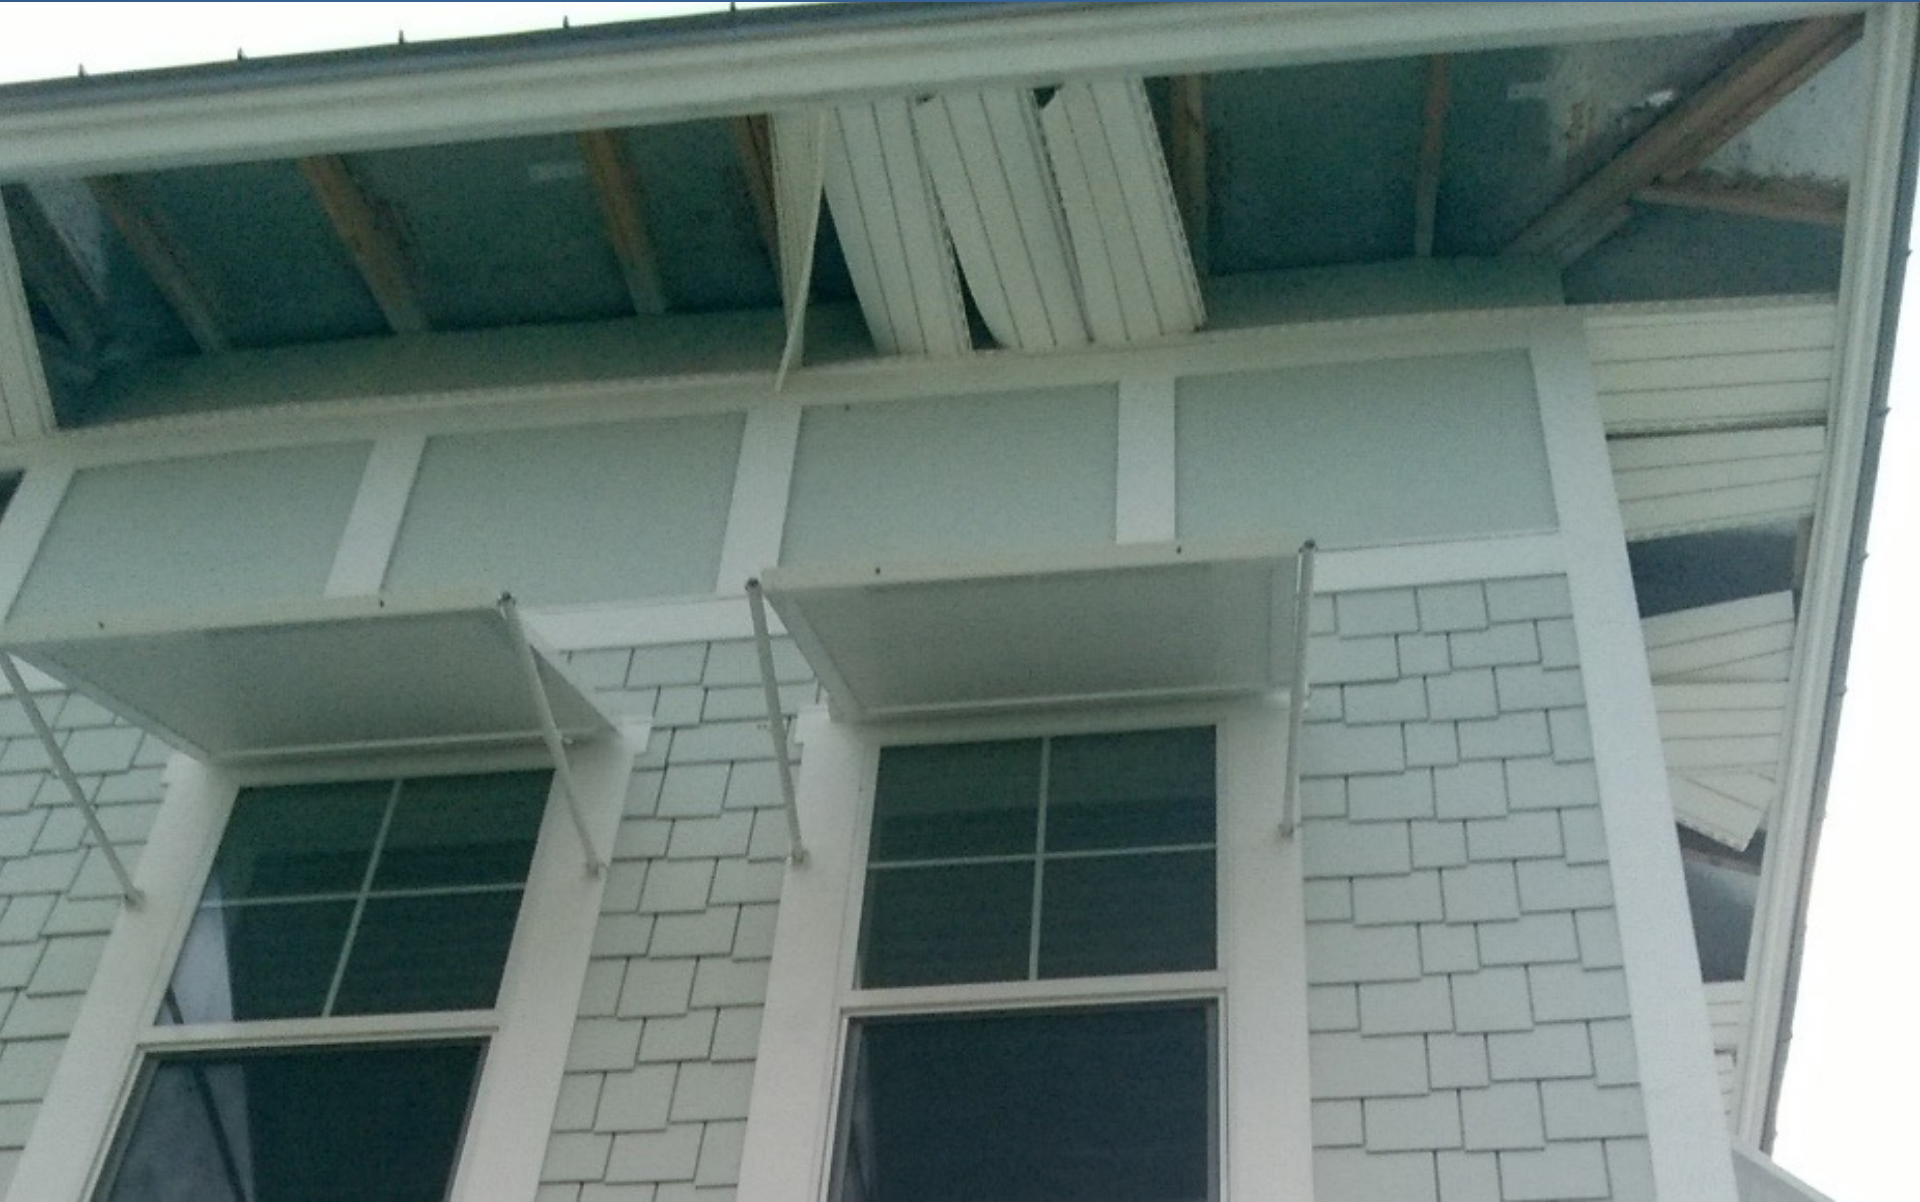
Shingle Failure
Primarily on North
Slope of Roof

Scattered Shingle Debris
Downwind of Home

Soffit Damage Observed to a Few Homes
