Preliminary Field Investigation of Damage Caused by Hurricane Matthew

David O. Prevatt, Ph.D.
University of Florida

Hurricane Matthew

September 28-October 9, 2016

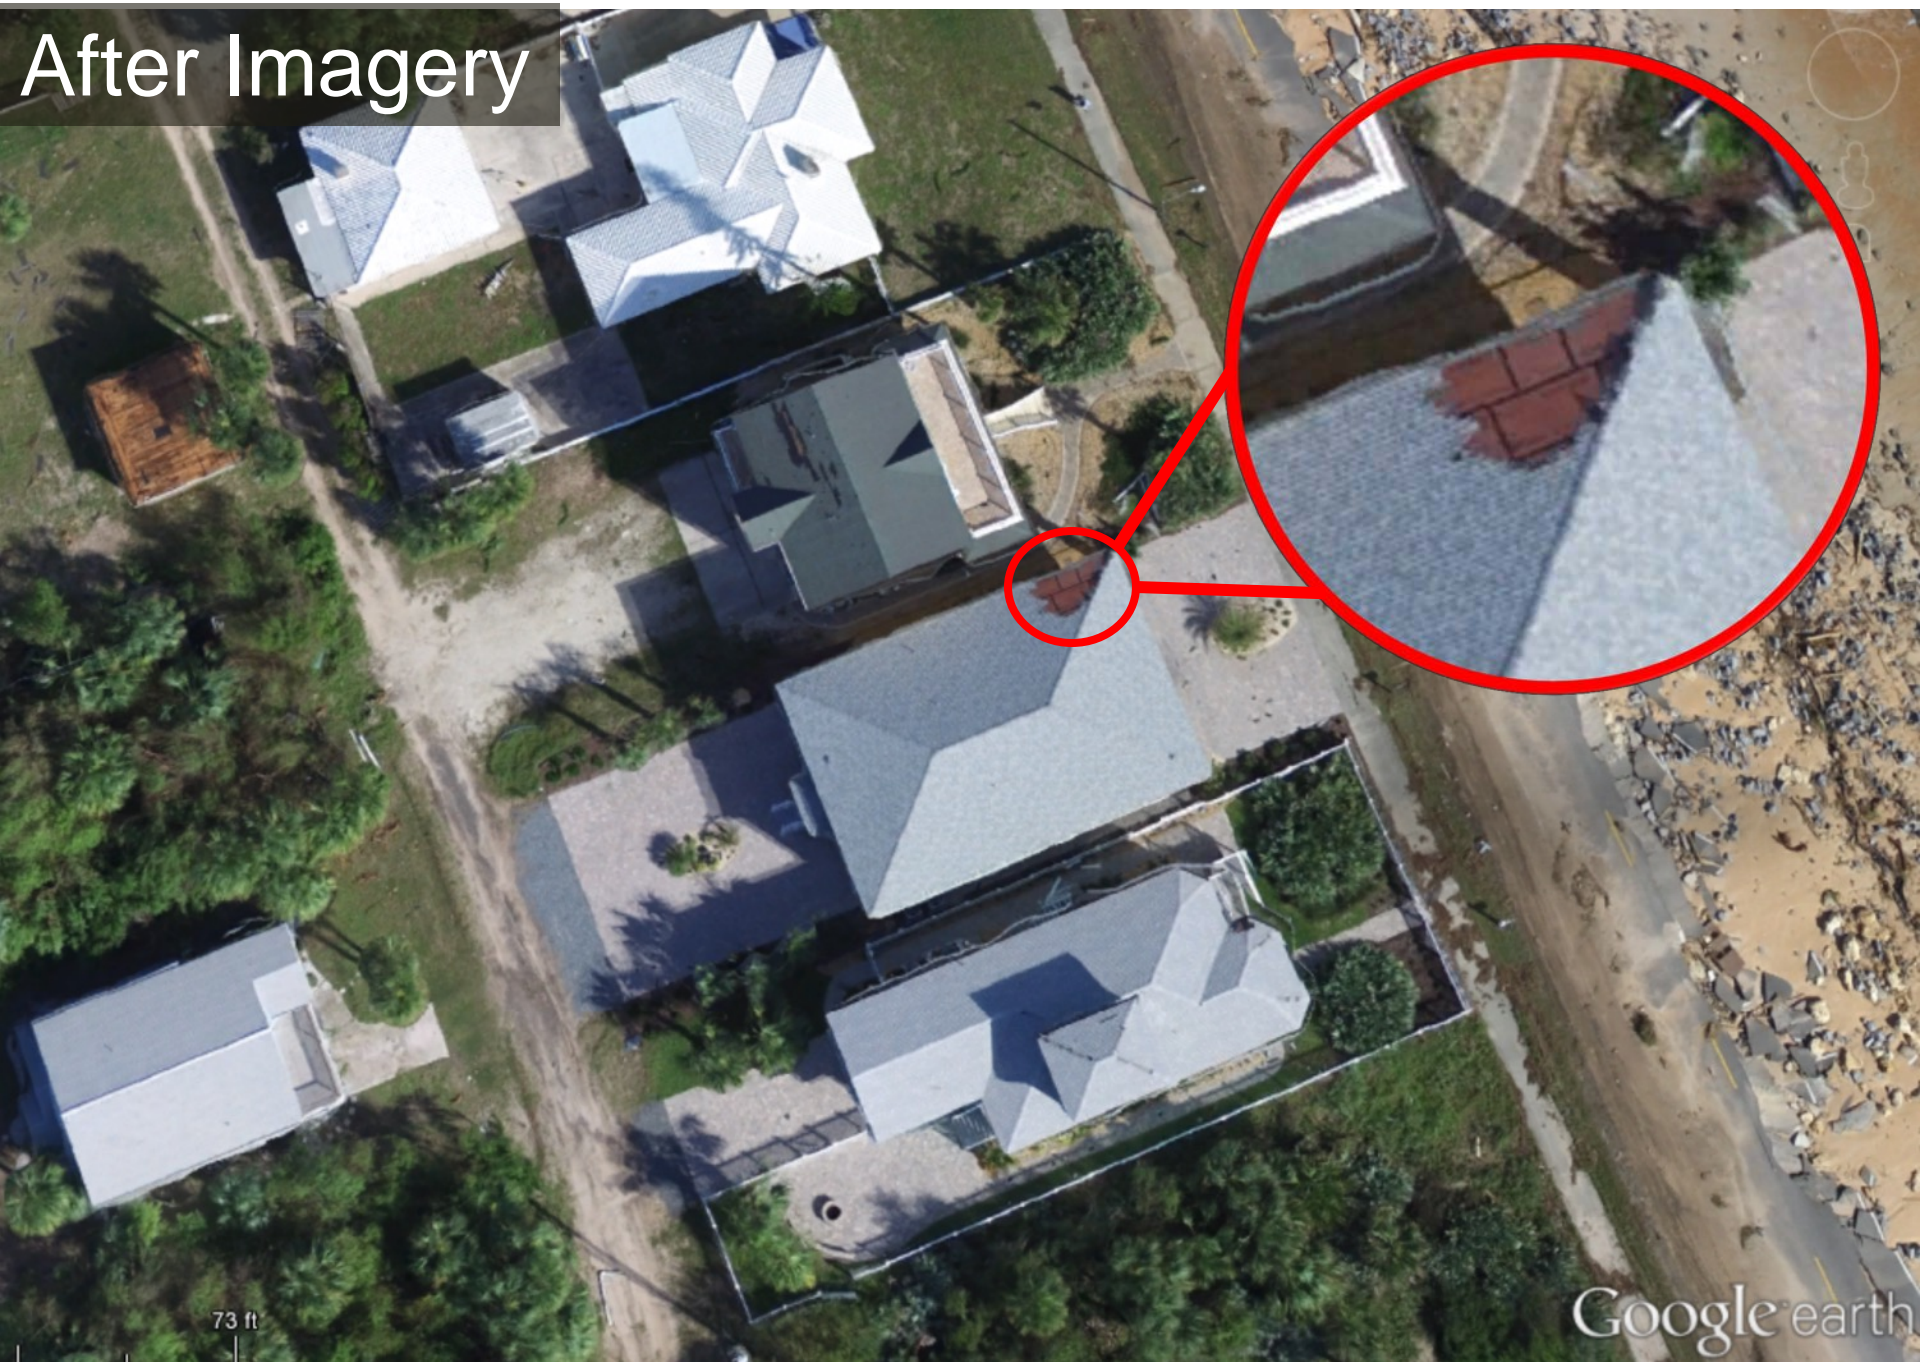
After Imagery

73 ft

1424 S Oceanshore Blvd, Flagler Beach, FL

Year Built: 2015

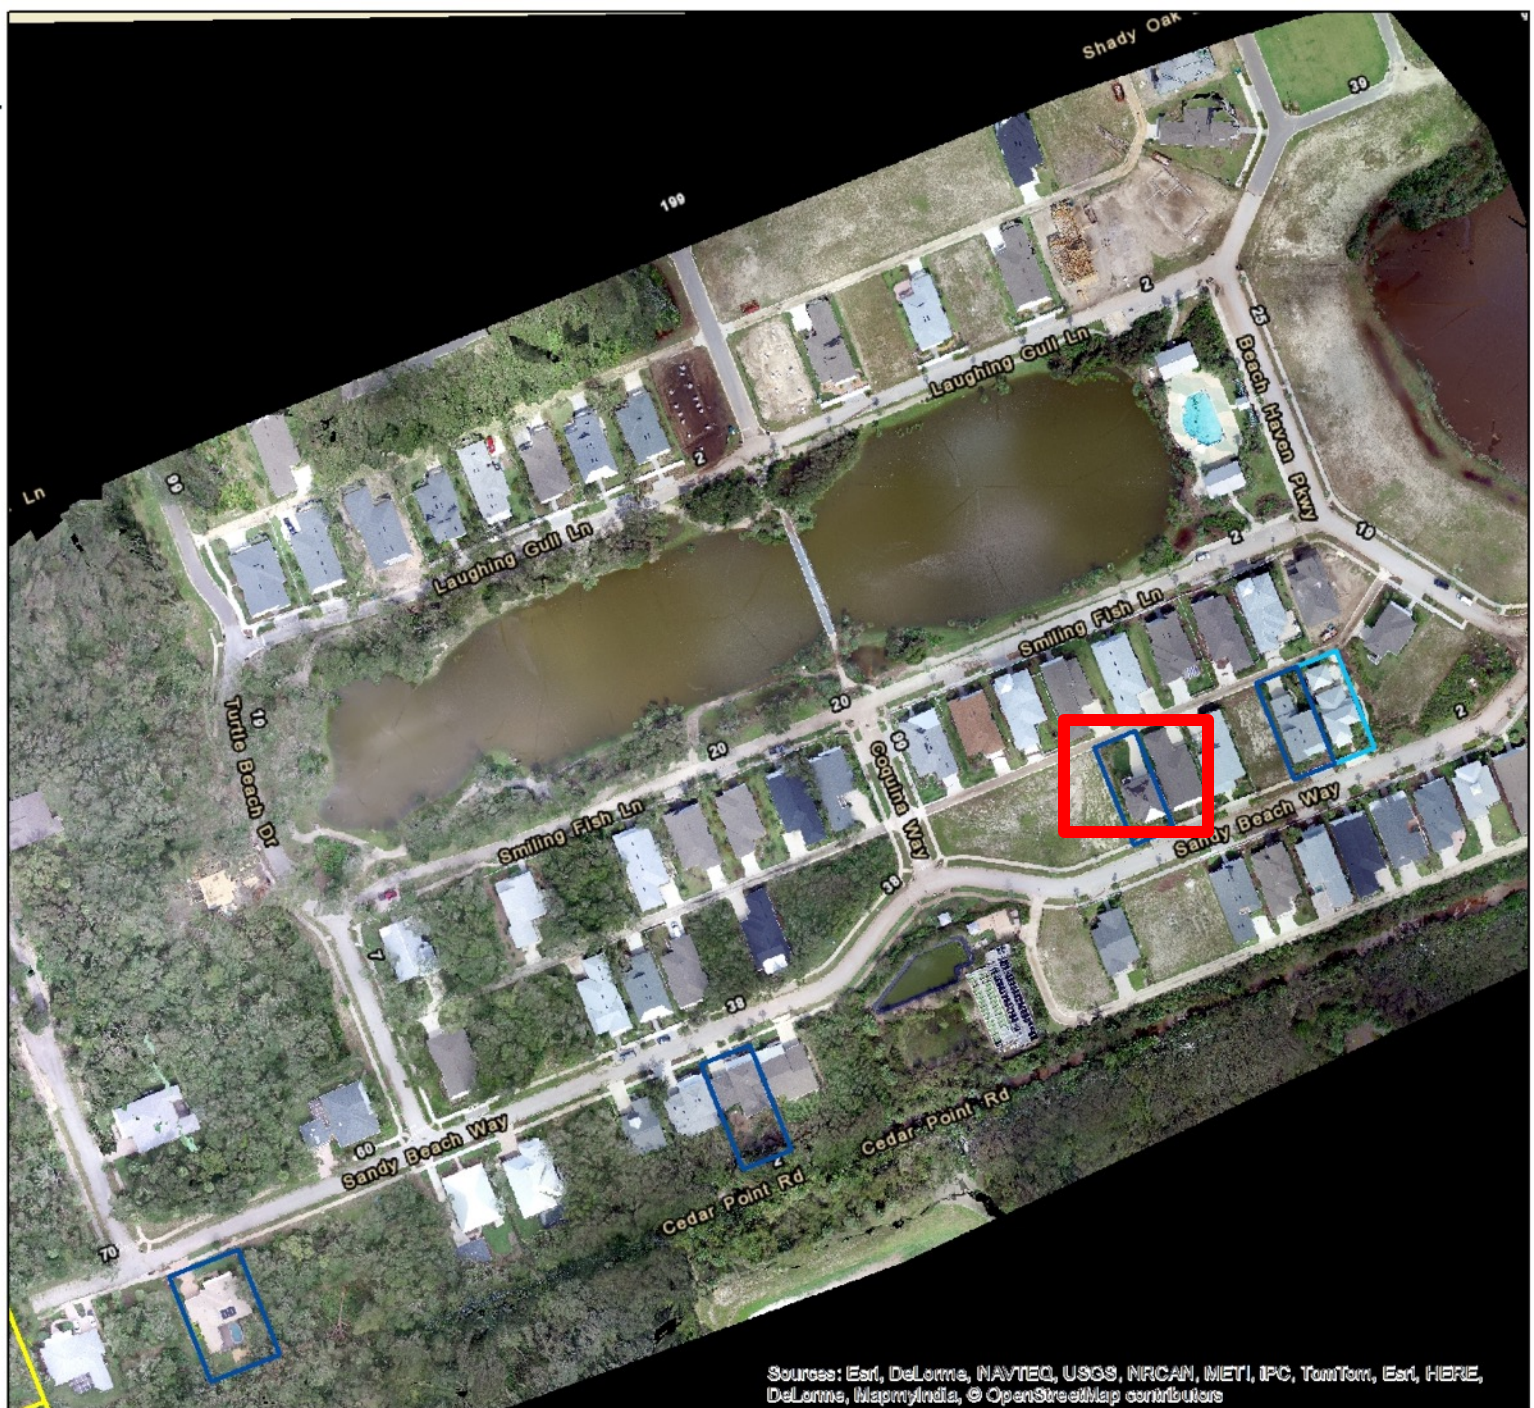
Marineland Flagler County, FL

An aerial photograph of a residential property showing a house with a grey shingled roof. A red arrow points to a section of the roof where shingles are missing, revealing the underlying structure. A red oval on the ground in front of the house contains numerous dark, rectangular pieces of shingle debris scattered across the lawn and sidewalk. A red line connects the oval to a text box at the bottom right.

Shingle Failure
Primarily on North
Slope of Roof

Scattered Shingle Debris
Downwind of Home

Soffit Damage Observed to a Few Homes
